**NJDOT Bureau of Research  
QUARTERLY PROGRESS REPORT**

<b>Project Title:</b>	Motorcycle Crash Analysis		
<b>RFP NUMBER:</b> 2008-17	<b>NJDOT RESEARCH PROJECT MANAGER:</b> Edward S. Kondrath		
<b>TASK ORDER NUMBER:</b> 12	<b>PRINCIPAL INVESTIGATOR:</b> Yusuf Mehta, Ph.D, P.E. Rowan University		
<b>Project Starting Date:</b> 1/1/2008 <b>Original Project Ending Date:</b> 06/30/2009	<b>Period Starting Date:</b> Jan 01, 2009 <b>Period Ending Date:</b> Mar 31, 2009

### INITIAL SITE INSPECTION OF MOTORCYCLE COLLISIONS WITH ROADSIDE OBJECTS IN NEW JERSEY

Paper Number 09-0450

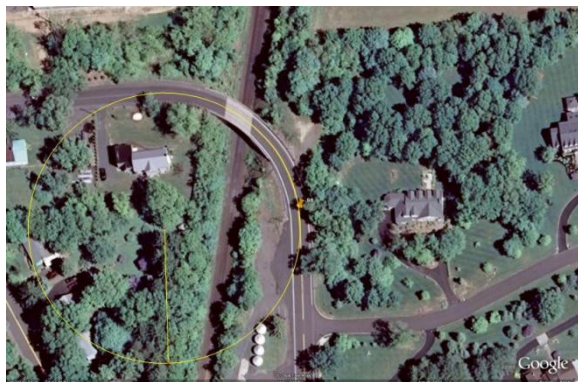
**Figure 1. Example radius of curvature measurement from Google Earth Pro.** This collision occurred in Mercer County on Route 640. The radius of curvature is 200 feet.

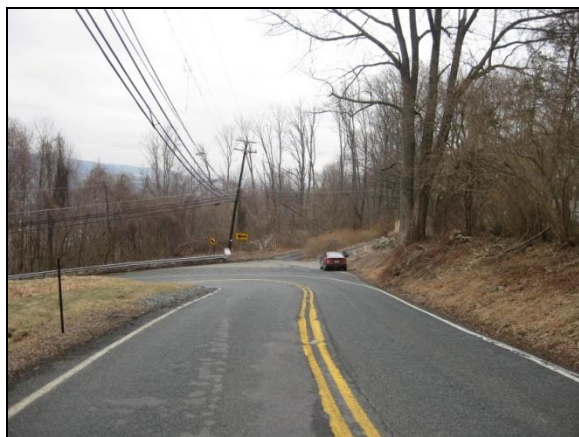
**Figure 3. Route 579, Bethlehem Township,**

On Route 579 in Bethlehem Township in Hunterdon County, a crash location was investigated where there were 4 motorcycle-guardrail collisions in 2007. The posted speed limit on the road is 35 mph, with a reduction to 10 mph around the curve. The road took a sharp turn left, and disappeared from vision due to the downgrade of the road (Figure 3). There were two driveways ending at the curve.

**Hunterdon County.** Four motorcycle-guardrail collisions took place at this site in 2007.

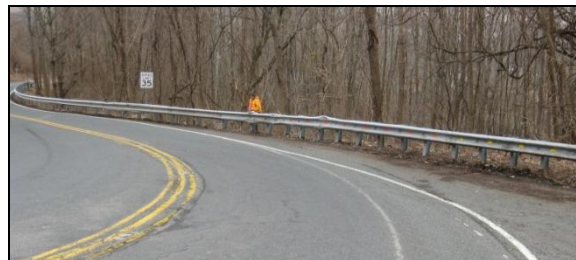
There were at least 5 areas of damage along the W-beam guardrail, suggesting other vehicle crashes had occurred on the same curve (Figure 4). Some of the steel strong posts were also bent and damaged.

**Figure 4. Damage to guardrail.** There is notable damage to the rail and the posts in multiple areas.

The distance of the guardrail from the edge of the lane gradually narrows as the road curves left. The guardrail-road offset distance was measured in three places to be 7.4, 5.0, and 4.0 feet from the edge of the lane. Along the curve, the guardrail was located only 0.75 feet from the edge of the pavement. The guardrail is in place to protect vehicles from the wooded slope behind it. The road slopes 11° in the direction of the road. The road angled 23° toward the center of the curve.

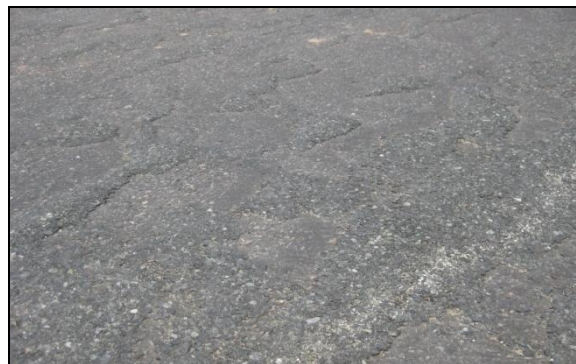
During the site visit, a street cleaner was seen at the site, implying that the site is well kept. There was little debris noticed on the side of the road as well. There were no potholes, patches, or large cracks in the asphalt surface of the road. However, the road was rough and uneven (Figure 5), which may be more hazardous for motorcycles than other vehicles.

**Figure 5. Road Surface.** The surface of the road was noted to be rough and uneven.

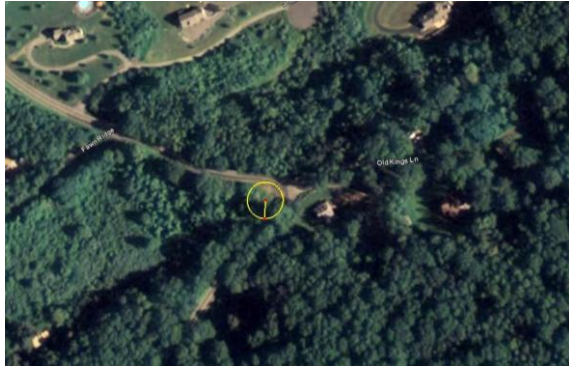
The geometry of the site was analyzed using Google Earth Pro. The radius of curvature of the site was measured to be 49 feet (Figure 6). This is a very narrow curve as none of the other sites investigated

using the satellite imagery were found to have a radius under 100 feet.

**Figure 6. Radius measurement of example site.**  
The radius of the curve was measure to be 49 feet.

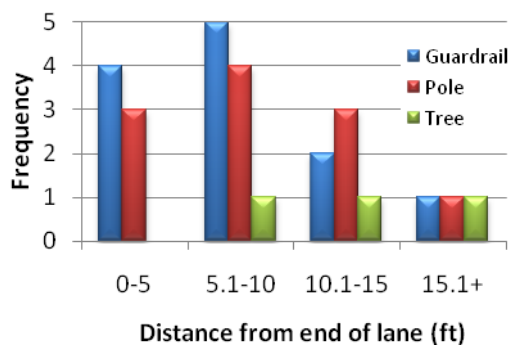
**Figure 7. Distance of object from lane edge by object struck.**

The distances of the objects from the edge of the lane varied greatly amongst the sites (Figure 7). There were sites where the guardrail was on the edge of the pavement on a street with no shoulder, and others where the guardrail was offset from the edge of the pavement on a road with a significant shoulder.

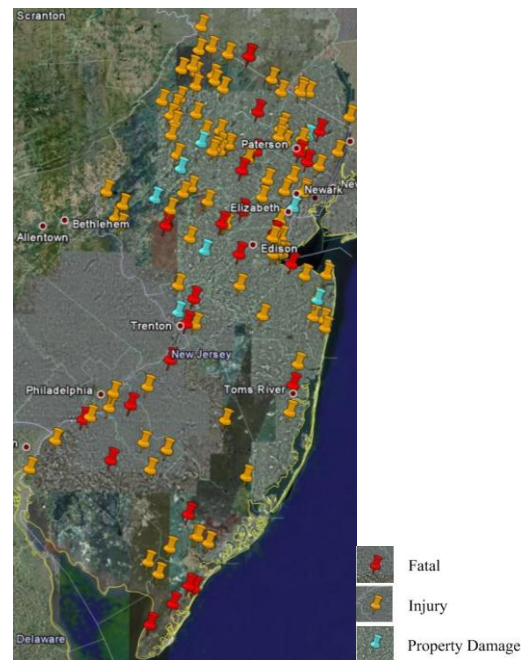
**Figure 8. Distribution of motorcycle-guardrail collisions in New Jersey (2005-2007).**

The distribution of the crashes across New Jersey was also found after each crash was analyzed (Figure 8). Most motorcycle-guardrail collisions were in northern New Jersey.
